**Ecologically Significant Wetlands and Rocky Outcrops in Mt Vernon Park:  
Characterisation, Impacts, Restoration and Future Management.**

GEOG309: Research for Resilient Environments and Communities

18th October 2024

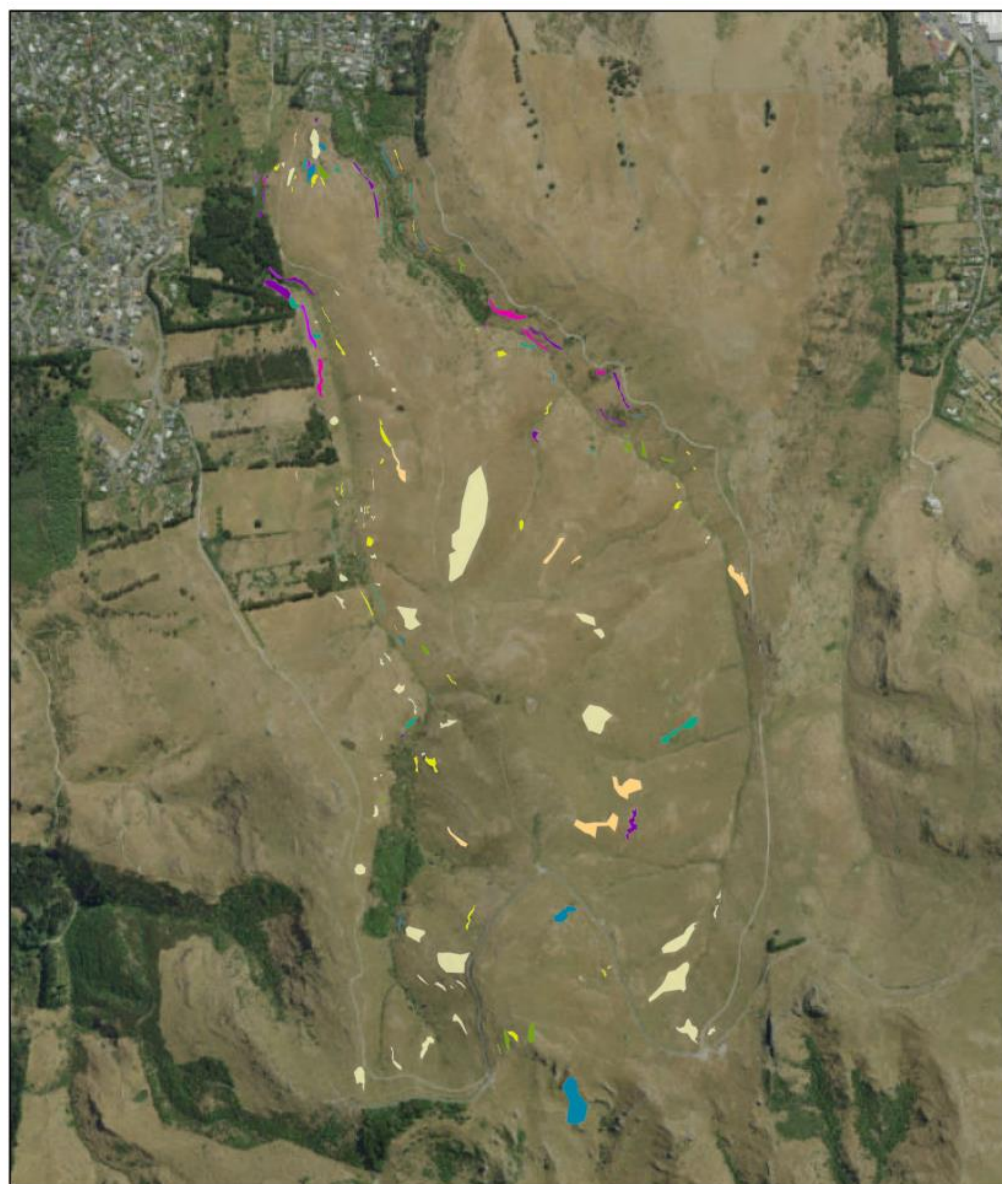
Figure 11

Map of Rocky Outcrop Health Classification

- 172 Rocky outcrops were identified, approximately 8.44% of the area at MVP (Figure 11)
- 47.67% of rocky outcrops had no vegetation (Figure 12)
- 4.65% have overstorey and 5.81% have midstorey (Figure 12)
- 14.53% rocky outcrops in good-optimal range (Figure 11)
- 27.9% rocky outcrops in the moderate range (Figure 11)
- 57.56% rocky outcrops in the poor-degraded range (Figure 11)
- 47.67% of rocky outcrops were in a closed area (Figure 13)
- 52.33% of rocky outcrops were in an open area (Figure 13)
- 81.4% of rocky outcrops are unfenced (Figure 14)
- 18.6% of rocky outcrops are fenced (Figure 14)
- Rocky outcrops face all aspects including 'broad inclined' (Figure 15)

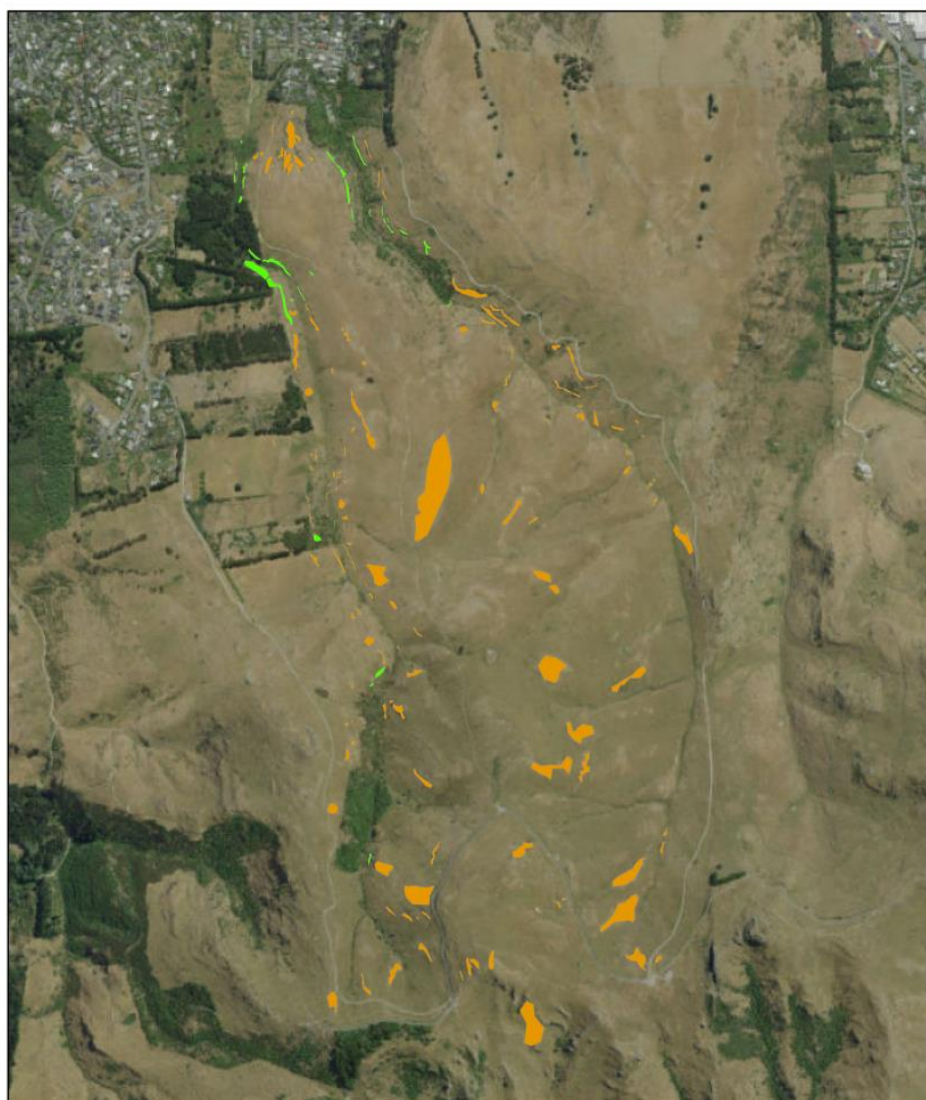
**Figure 14**

*Map of Protection showing Fenced and Unfenced Rocky Outcrops*

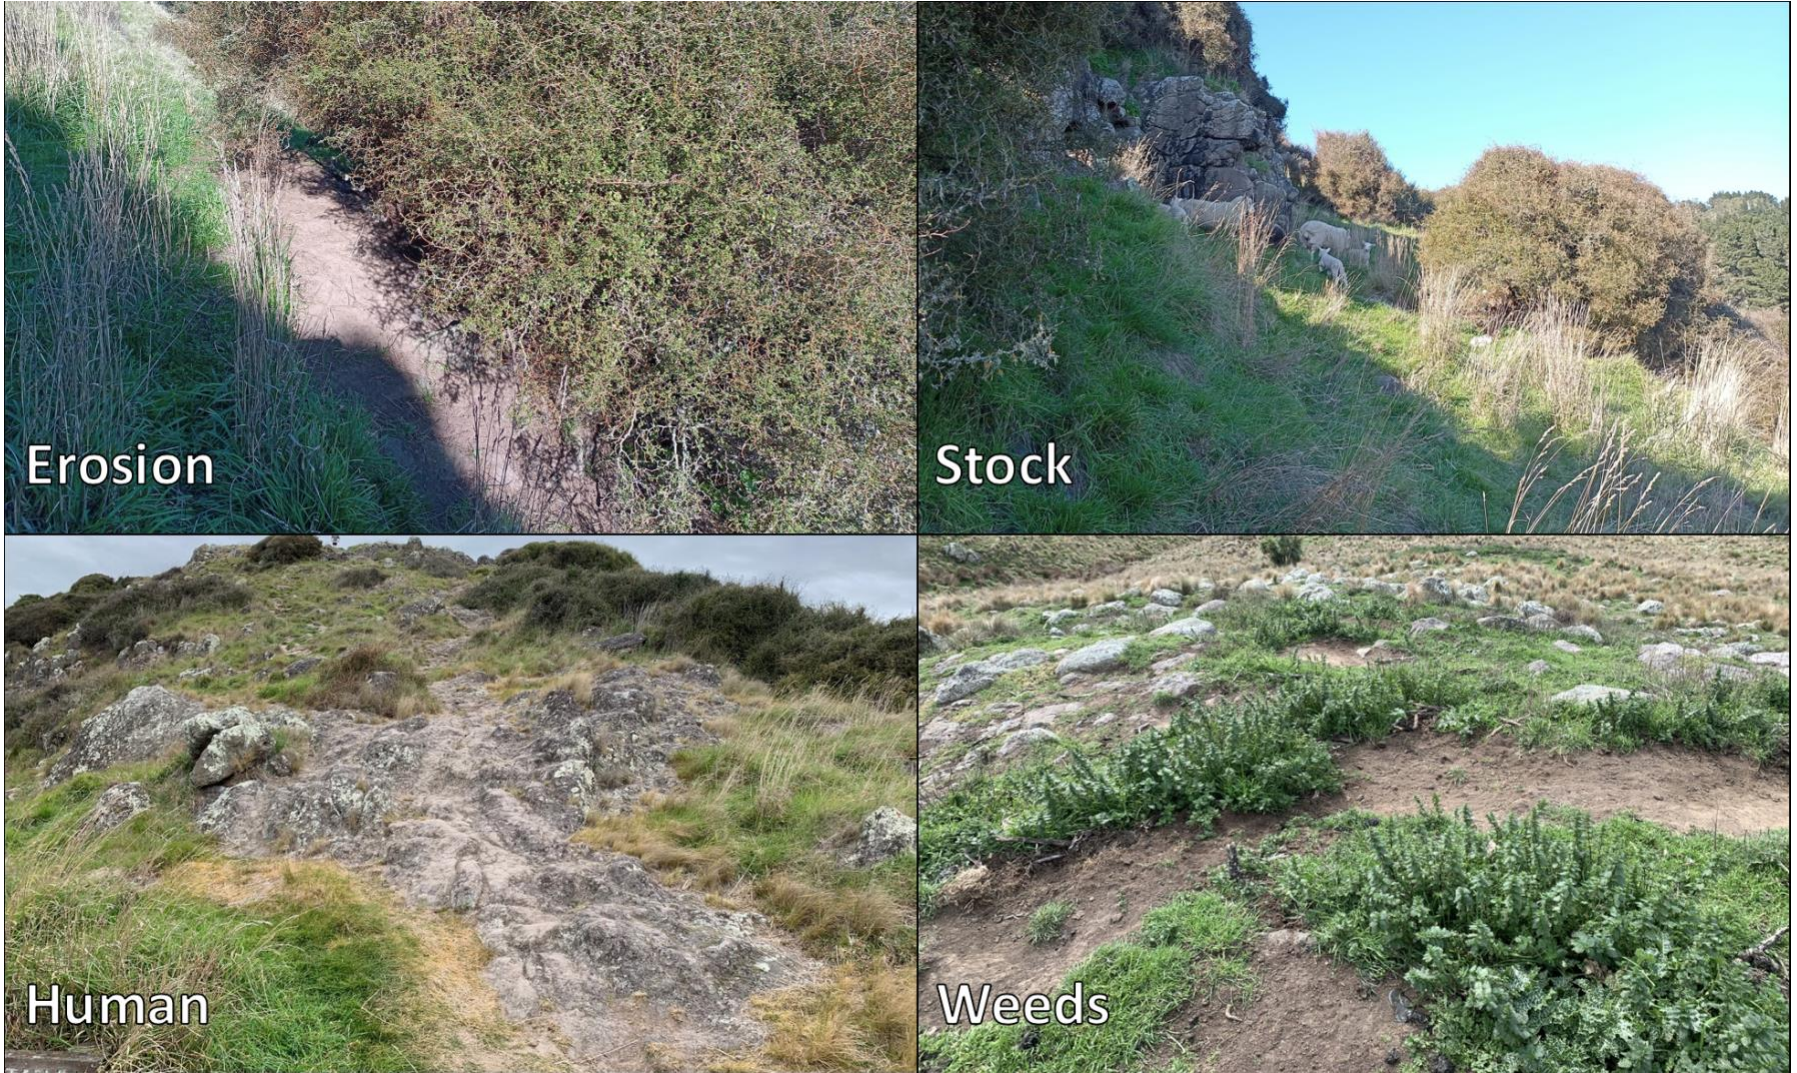
**Figure 17**

*Examples of Threats to Rocky Outcrops at MVP*
