Impacts, Assessments and Recommendations for Stormwater
Drainage Management in Okains Bay

Thomas Costello, Harrison Cullen, Florence McKenzie,
Maya Thordarson & Abbey Webb

University of Canterbury

18th October 2024

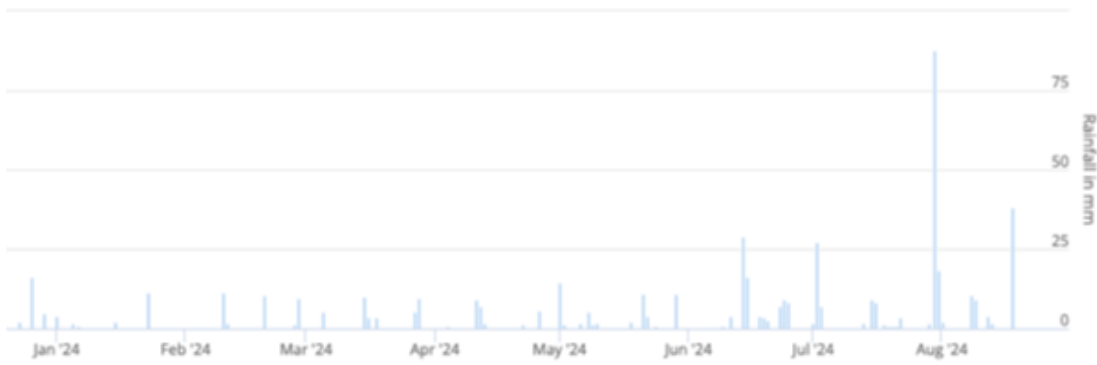
Figure 4. Rainfall data from a NIWA monitoring station at nearby Akaroa (Environment Canterbury (ECAN. 2024). Rainfall for Akaroa EWS (NIWA)).

Rainfall data collected from a NIWA station at Akaroa over the past year reveals several significant rainfall events. Including an event during the field study visit where 26mm of rain fell in a short period in late July (Figure 4). Observations during this rainfall event, combined with the collected data, provide valuable insights into the hydrological response in Okains Bay. The interaction between the catchment's topography, soil types, and rainfall patterns highlights the challenges of managing drainage in the area, especially during intense storm events.

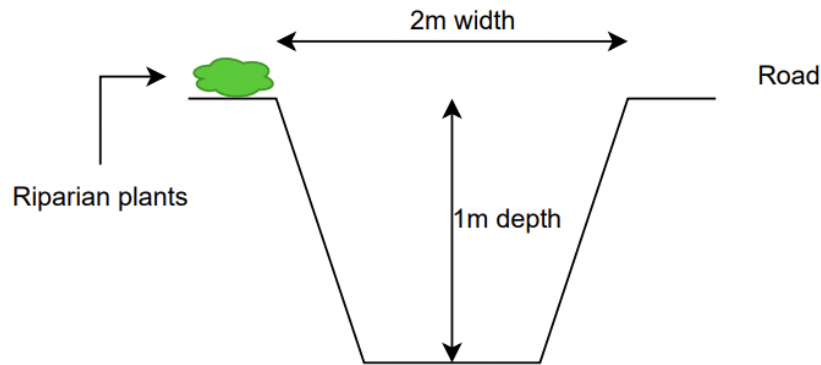
Figure 10. Traditional ditch design. Ditches allow for fast and effective water diversion from the area through the simple design. Deep and steep, allowing water to flow directly through without interruptions. However, it does not provide erosion control, sediment reduction or pollution reduction.

Options	Purpose	Locations	Engineering designs
Ditch re-design	Offers fast and efficient channel for diverting excess water away from the area	Ditches areas less than 5m in width along the road	Ditch design with a depth of 1 metre and width of 2 metres. See Figure 10.
Swale re-design	It provides benefits to water quality and sediment runoff and allows for water infiltration.	Swales in areas wider than 5m in width along the road	Swale design with a depth of 1 metre, width of 3 metres, and main channel width of 1.5 metres. See Figure 11.
Planting along the network	Addition of riparian plants alongside stream banks for increased stability and naturalisation of the system	Drains that flow into the estuary Stream with Flap Gate Along roadside areas away from roads and accessways	Riparian planting areas alongside swale and ditch designs. See Figure 10 & 11.

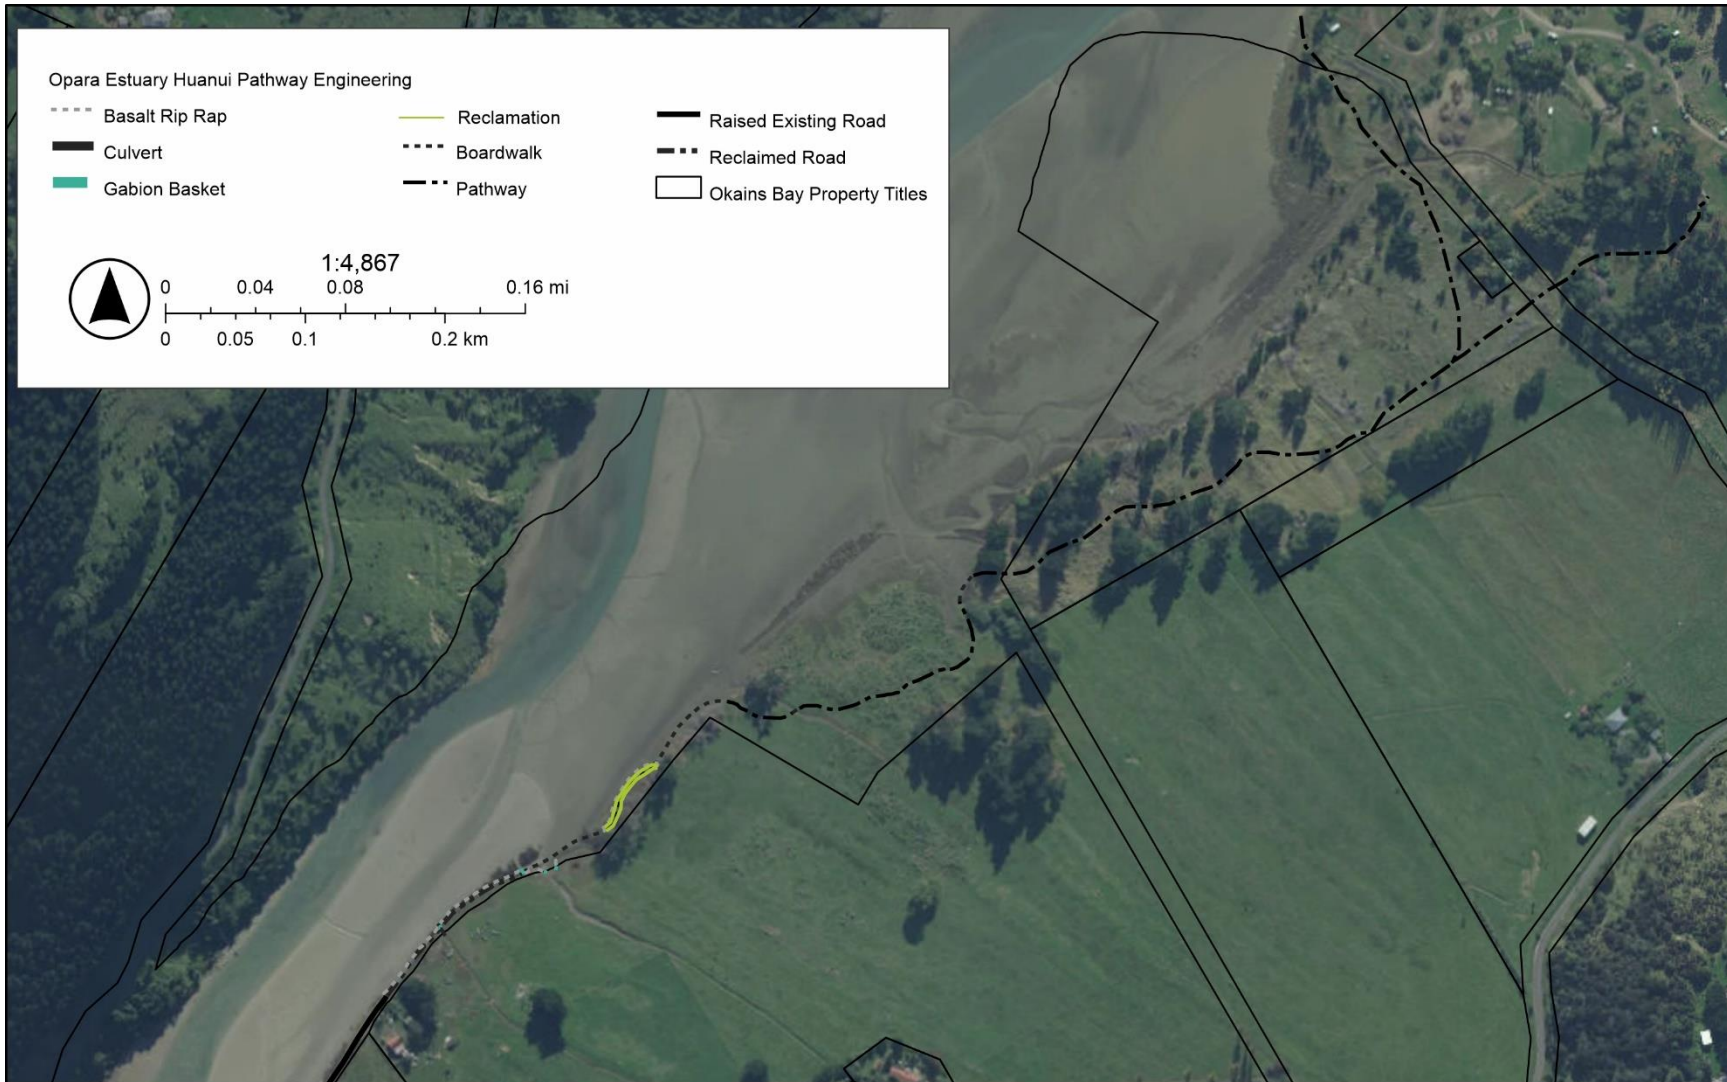
Figure 18. Opara Estuary Huanui Pathway with suggested basalt rip rap, culvert, gabion basket, reclamation, boardwalk, pathway, raised existing and reclaimed road.

Solution	Purpose	Benefits	Source	Location
Basaltic rip rap:	Shoreline stabilisation due to the strength and durability components.	Minimise erosion conditions from high-energy wave activity and heavy rainfall.	Able to be sourced from local geological composition.	Figure 18 and 19.
Culverts:	Stabilise the soils neighbouring the river and create resilience during flooding events (Figure 14).	Provide flood barrier, reduce overflow of water and prevent soil erosion (Khan, 2023).		River side located in Figure 18 and 19.
Gabion baskets:	Wire mesh holds the stones together, enabling water to flow through.	Control erosion, the river lining and slope stabilisation.	Locally sourced basaltic stones.	Targeted locations in Figure 18 and 19.
Land reclamation:	Build up the road along the estuary that has previously been eroded.	Offers flood protection to pathway infrastructure.	Local basalt. Excavated sediments from excavation and ongoing sediment trap maintenance.	Figure 18 and 19.

Elevated boardwalk:	Boardwalk. A long-term boardwalk won't be eroded by the influence of sea level rise, rainfall events and climate change (Ferreira, 2023).	Promote awareness of the values of the local ecological system. Public walkway.		Over the river, estuary shown in Figure 18.

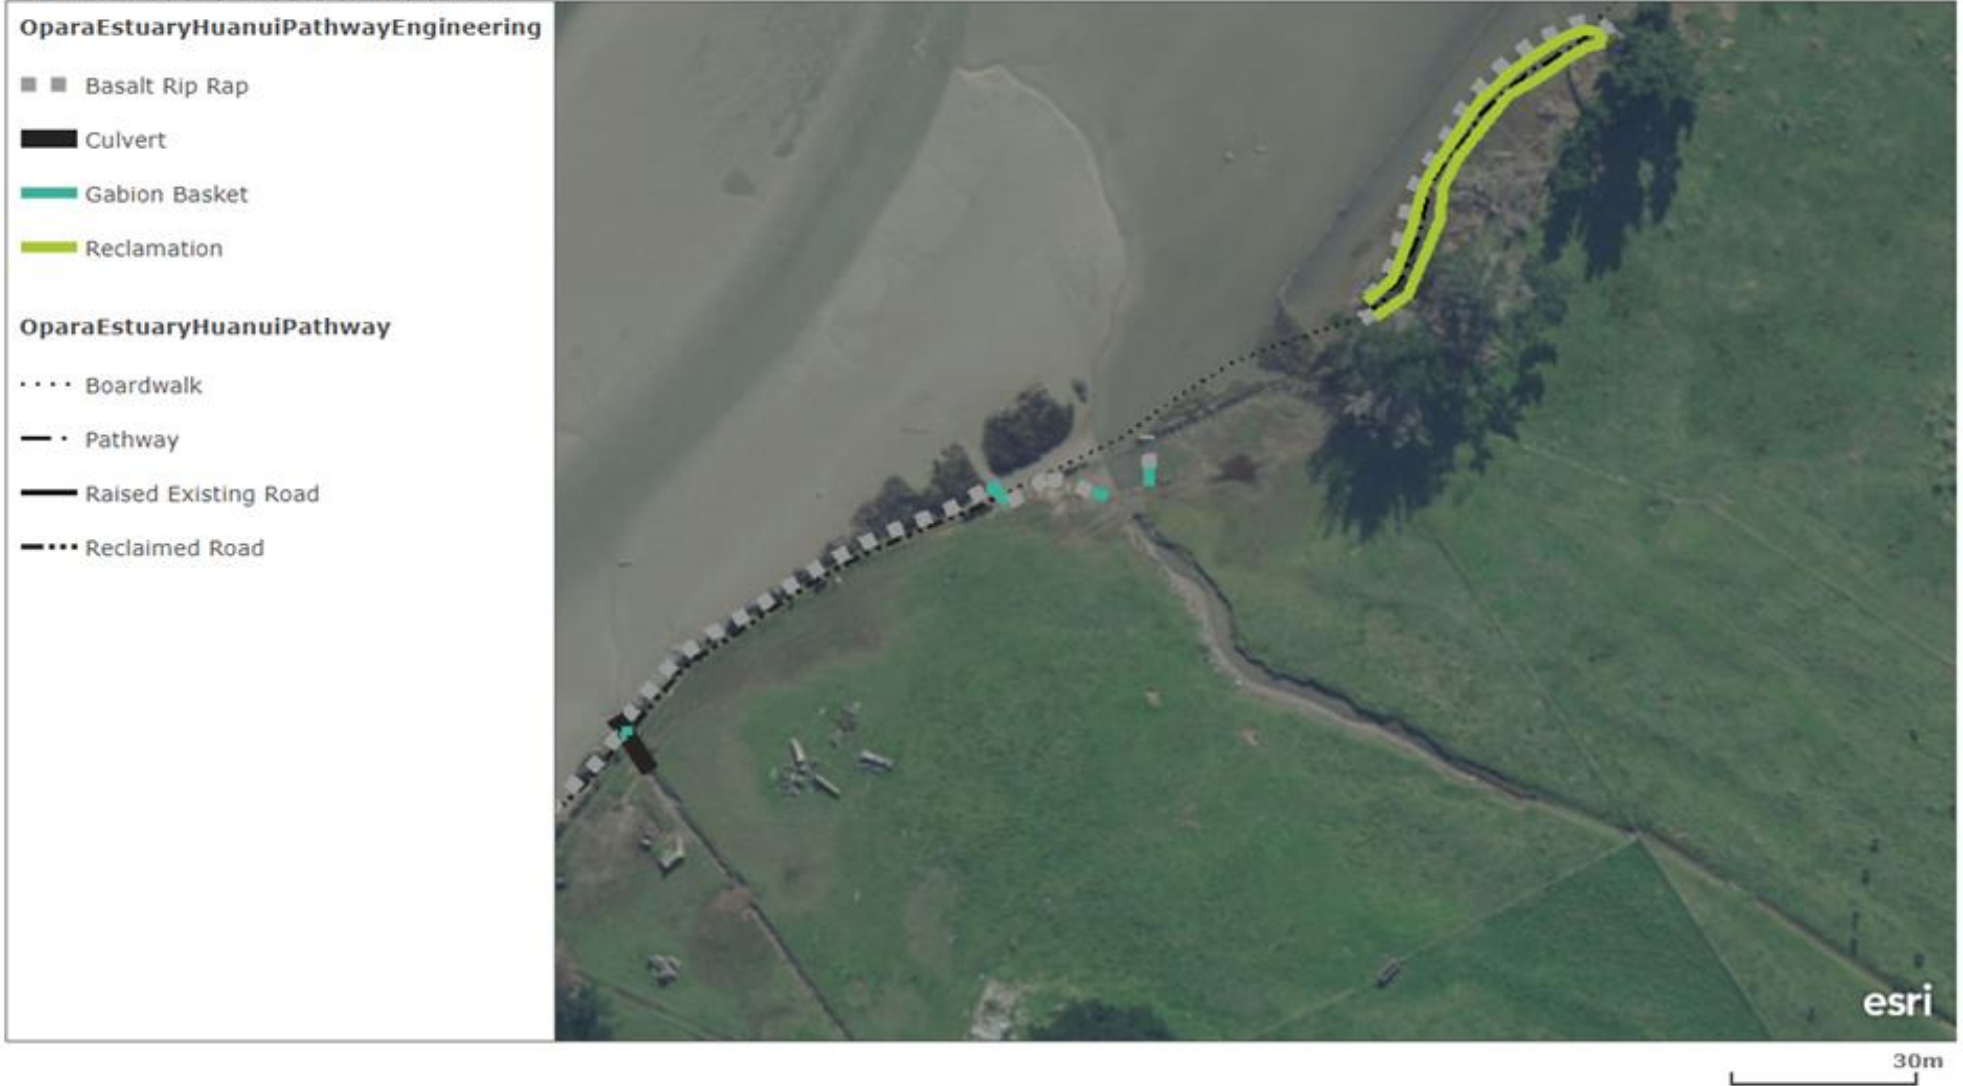
Figure 19: Opapa Estuary Huanui Pathway close-up highlighting the locations of basalt rip rap, culverts, gabion basket, reclamation, boardwalk, pathway, raised existing and reclaimed paper road.

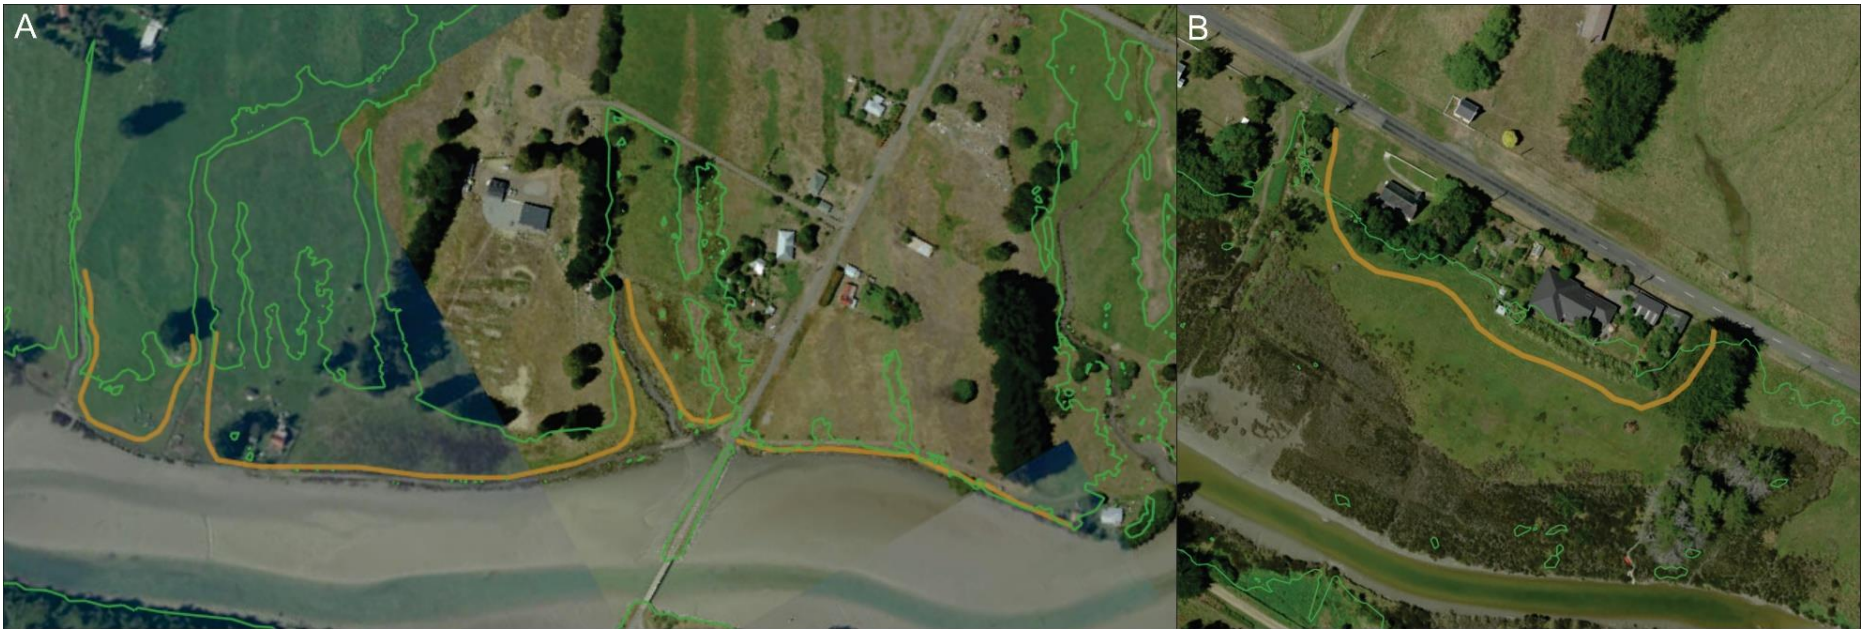
Figure 20: Proposal of inundation bunds to protect low lying assets and productive farmland. Localised protection provides by inundation bunds constructed from excavated sediment from drainage network. Inundation bunds depicted as orange lines extend from lower land areas to meet 1.5 m contour line, depicted as green lines. A) Areas at low lying levels proximal to Churlton Road Bridge. B) Low lying areas of St John the Evangelist Church and the Vicarage.

Localised inundation bunds are embankments constructed with excavated sediment from the maintained drainage system. Using these locally sourced materials reduces costs as dumping is not required. Compacted bunds can be covered with a geotextile and planted to protect and minimise erosion.

It is proposed that inundation bunds be used to protect assets or productive land from sea level rise and flooding events. Two examples of inundation bunds placement to protect low lying properties are indicated in Figure 20. Bund placement in these examples extend the 1.5m contour height towards the estuary edge. Inundation bunds need to be located to connect with surrounding topographic highs and account for incised drainage so to not result in surface water collecting behind the embankment or resulting in the diversion of surface water runoff.
