# Planning for Flooding at Trees For Canterbury

University of Canterbury - 18/10/2024

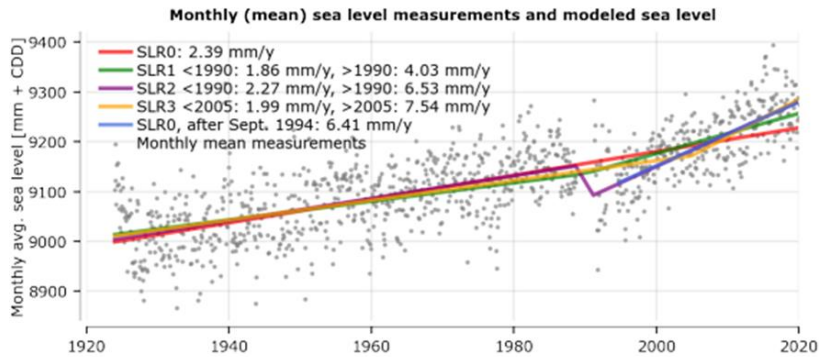
Figure 5 This graph shows a positive linear line of sea level rise from 1920 to 2020 illustrating the constant increase of sea level in New Zealand (Christchurch City Council, 2021).

sheets and glaciers melt, and ocean waters expand, as illustrated by historical tide station records in figure 5.

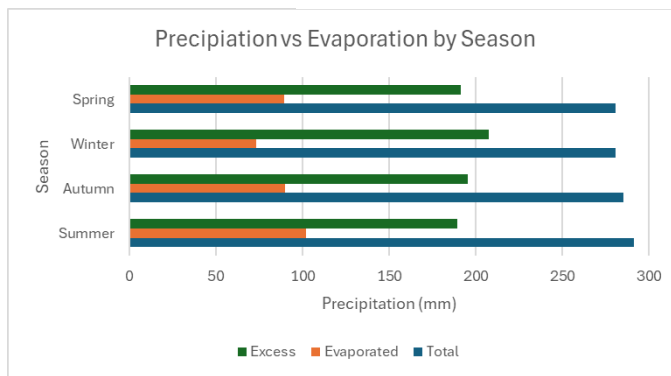
Figure 9 Excess evaporation table and graph using Hargraves formula with data supplied from NIWA

The evaporation results can be seen below (figure 9). It was found that all seasons see a significant surplus of precipitation, but balance to approximately the same, with irrigation accounting for the dry periods in the warmer seasons. Despite being the warmest and driest
